Intel[®] 80321 I/O Processor

Specification Update

May 12, 2003

Document Number: **273519-010**

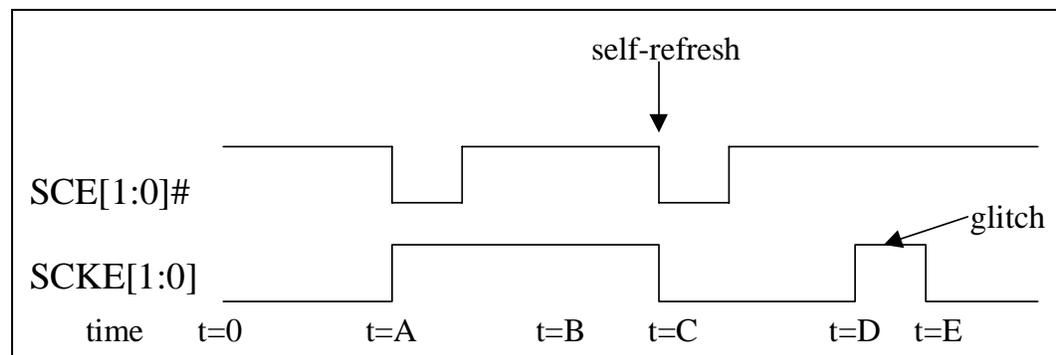
7. SCKE[1:0] Contention During a Power Failure

Problem: During power failure, the Memory Controller Unit (MCU) issues a sequence of commands to the DDR memory that puts the memory into self-refresh mode. The data is preserved in the DDR memory as long as the memory subsystem is powered with a battery source and SCKE[1:0] is held low.

While the memory is in self-refresh mode, the SCKE[1:0] signal remains low. The problem is that SCKE[1:0] is incorrectly driven high for n M_CLKs, soon after it was driven low. This causes the DDR memory to exit self-refresh mode, therefore data integrity cannot be guaranteed.

4. From $t=B$ to $t=C$ a power fail event occurs. The MCU completes its routine at $t=C$, at which time SCKE[0] is driven to '0' and the DDR memory is put into self-refresh mode.

5. However, soon after $t=C$ (about 2 - 4 M_CLKs later), the SCKE[0] “glitches” (SCKE[0] is driven to '1'). The length of time from $t=D$ to $t=E$ varies depending on the ability of the 80321 to issue the internal reset. Simulation has shown the width of the “glitch” to be 0 to 2 M_CLKs. However, this may vary with internal bus activity and the ability of the 80321 to service the reset when the power fail sequence is done. This “glitch” on the SCKE[0] signal causes the DDR memory to exit self-refresh mode.

6. At $t=E$, the falling edge of the SCKE[1:0] “glitch” is synchronous with the assertion of M_RST#.

Workaround: See the workaround for Item 9.

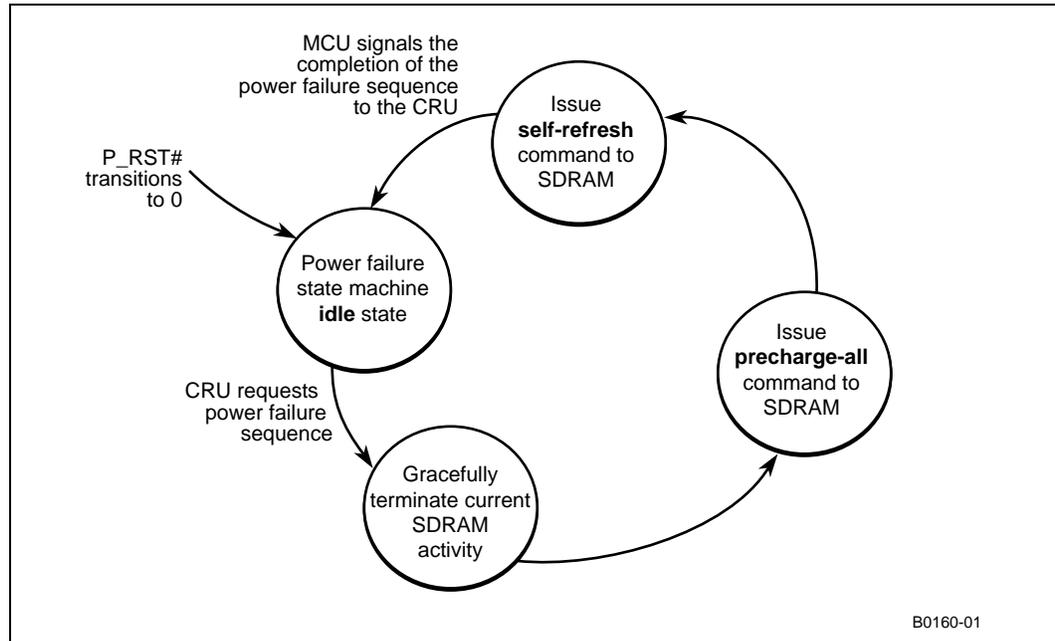
Figure 2. Power Fail State Machine

9. Improper Power Fail Sequence During a Power Failure

Problem: During power fail, the Memory Controller Unit (MCU) issues a sequence of commands to the DDR memory that issues an auto-refresh command followed by a self-refresh command that puts the memory into self-refresh mode. The data is preserved in the DDR memory as long as the memory subsystem is powered with a battery source and SCKE[1:0] is held low.

The minimum clock count between the auto-refresh command and the self-refresh command is eight clock cycles, to allow enough time for the DDR state machine to complete the auto-refresh command in the power fail sequence. The problem is that the number of clock cycles between these two commands is only four clock cycles. Therefore, the self-refresh command is not recognized by the DDR state machine, because the DDR state machine is still executing the auto-refresh command. Since the self-refresh command is missed by the DDR state machine, the DDR never enters self-refresh mode. Therefore, DDR memory data integrity cannot be guaranteed.

Workaround: Convert the auto-refresh command, during the power fail sequence, to a self-refresh command and to hold the SCKE[1:0] signal low until the POR# pin is deasserted. The circuit for this workaround is shown below. This circuit also provides the workaround for Item 7. PLD equations for this circuit are available upon request.

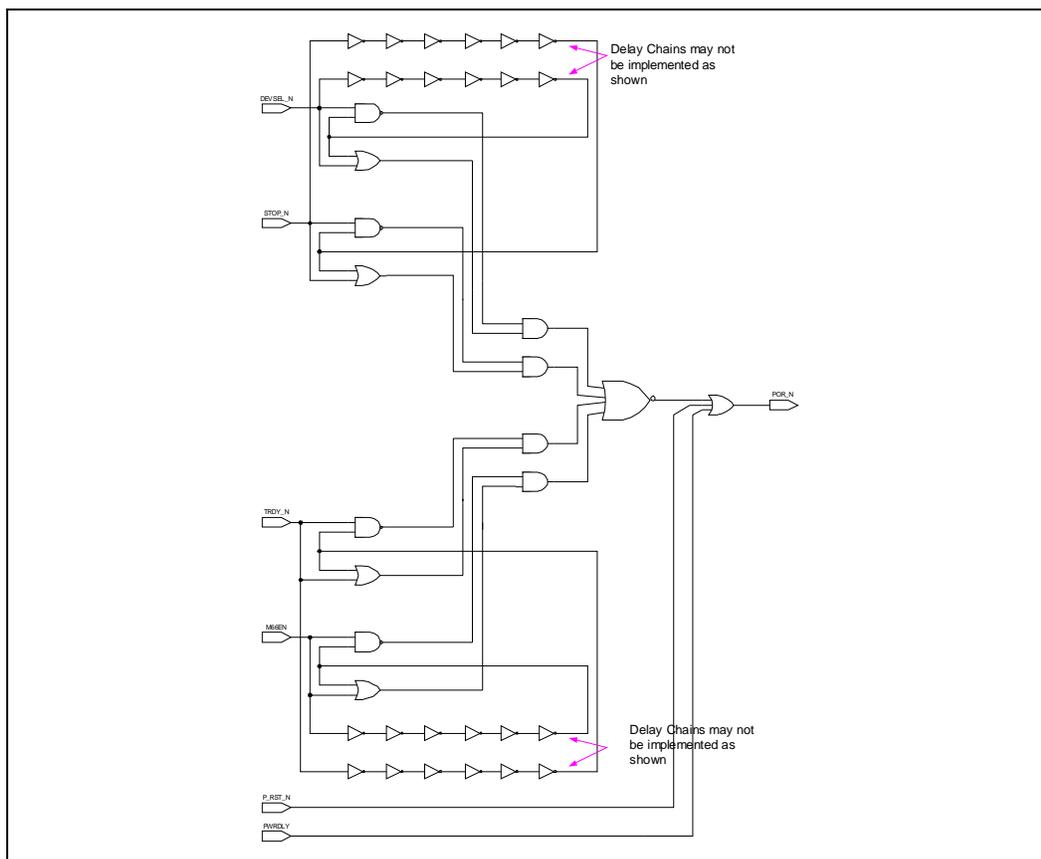
10. PLL Unable to Lock at Reset

Workaround: Pulse the POR# signal once the PCI-X initialization pattern frequency matches the P_CLK, before the rising edge of P_RST#. An example circuit for this workaround is shown in the following diagram. PLD equations for this circuit are available upon request. The function of this circuit is to pulse the POR# pin when there is any change in the PCI-X initialization pattern, prior to the deassertion of P_RST#. A pulse width of approximately 200 ns is required. This allows the PLL to reset and latch the correct PCI-X initialization pattern to ensure proper PLL operation upon coming out of Reset.

When entering PCI-X mode, the M66EN signal needs to be held high **from power-up until the rising edge of P_RST#**.

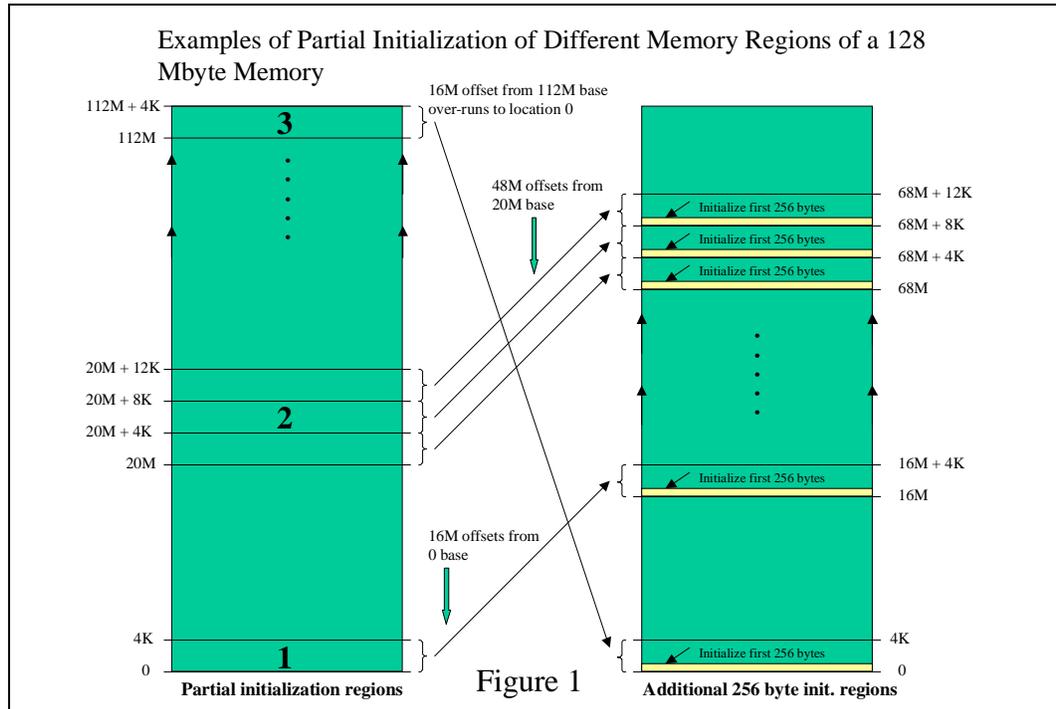
Figure 1. Partial Memory Initialization Examples

15. A logic error in the Memory Controller Unit (MCU) incorrectly reports an ECC Error on memory writes. This error does not corrupt memory contents or data. There are two different conditions that exacerbate the issue.

Item 1: The guidance in servicing an ECC event for a fully scrubbed DDR SDRAM, is to service each ECC event that is reported by the MCU, even though there exists a very small chance that the ECC event that caused the MCU to report, was not in an area of memory that was intended on being read (in which case the address in the ECAR would be incorrect).

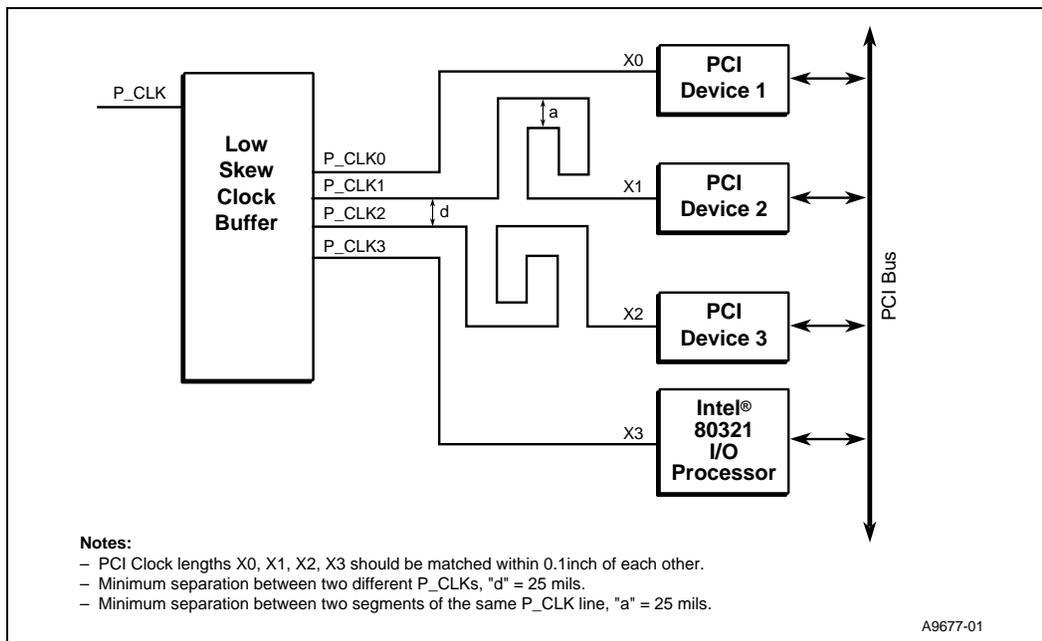
Problem: The second note shows "...set __CLKs...". It should read "...set P_CLKs...".

Workaround: Replace Figure 14 with the following:
