Intel[®] 80321 I/O Processor

Specification Update

May 12, 2003

Document Number: **273519-010**

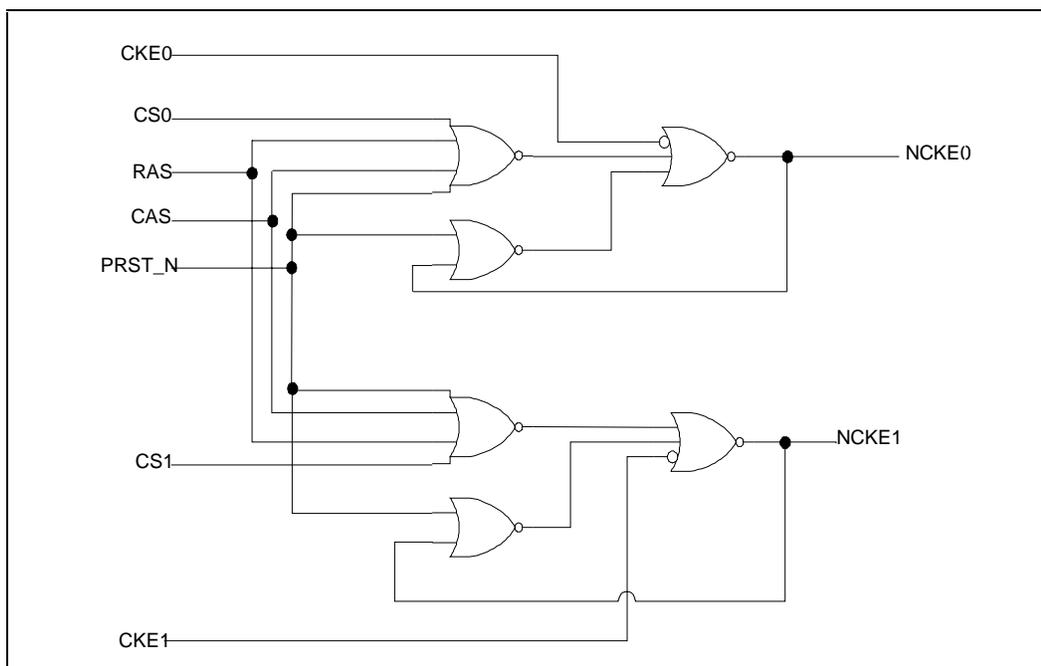
Figure 2. Power Fail State Machine

The minimum clock count between the auto-refresh command and the self-refresh command is eight clock cycles, to allow enough time for the DDR state machine to complete the auto-refresh command in the power fail sequence. The problem is that the number of clock cycles between these two commands is only four clock cycles. Therefore, the self-refresh command is not recognized by the DDR state machine, because the DDR state machine is still executing the auto-refresh command. Since the self-refresh command is missed by the DDR state machine, the DDR never enters self-refresh mode. Therefore, DDR memory data integrity cannot be guaranteed.

Workaround: Convert the auto-refresh command, during the power fail sequence, to a self-refresh command and to hold the SCKE[1:0] signal low until the POR# pin is deasserted. The circuit for this workaround is shown below. This circuit also provides the workaround for Item 7. PLD equations for this circuit are available upon request.
